TOWN OF SALISBURY ENERGY AUDIT REPORT TOWN HALL, LIBRARY, DPW BUILDING

DATE: JANUARY 23, 2020

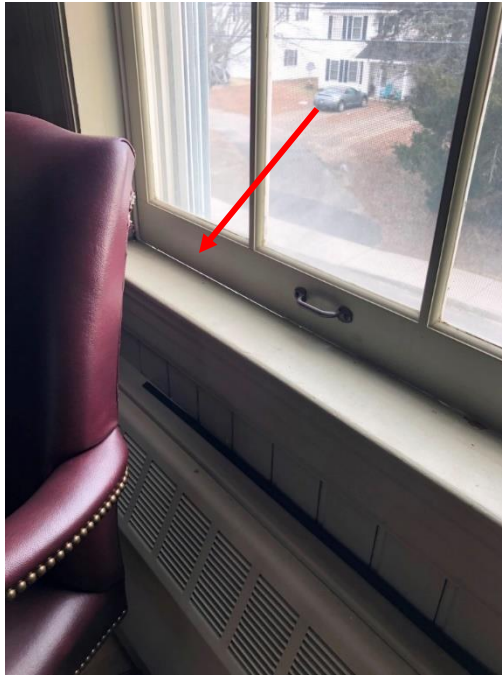
- Interviews with facilities staff indicated that the building's walls are not currently insulated. ENE Systems would recommend insulating the wood frame 2x4 wall system with blown in cellulose insulation. This will more than double the overall wall system R-value bringing the total to R-21. Increasing the walls' R-value slows the transfer of heat thus saving HVAC heating and cooling energy.
- Further investigation should be performed in the attic space to check the condition of the insulation. Most of a building's heat is lost through the roof.
- Several air gaps were observed in the windows. Air gaps allow unconditioned outside air to enter the building disrupting occupant comfort and increasing energy costs. ENE Systems recommends that all windows and doors are further inspected for air gaps and repaired accordingly.

Figure 1: Air Gap in Second Floor Window

- It was observed that the windows are all single pane. Double pane windows have approximately double the R-value of single pane windows. It is recommended that the first floor windows be either retrofitted or replaced with double pane windows. The second floor windows have been replaced recently but could be a candidate for retrofitting with double pane glass.

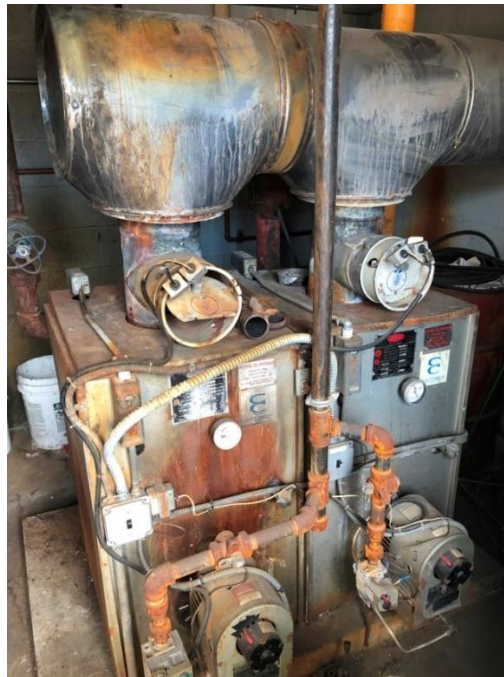
- The two existing boilers are 42 years old and are approaching the end of their useful life. ENE Systems recommends that the existing 80% efficient boilers be replaced with a single condensing 96% efficient boiler. To implement this measure, the existing vented door will need to be replaced with a solid one, new flue and combustion air venting will need to be installed, and a unit heater will need to be installed in the mechanical room to prevent possible freezing issues.

Figure 2: Existing Hot Water Boilers

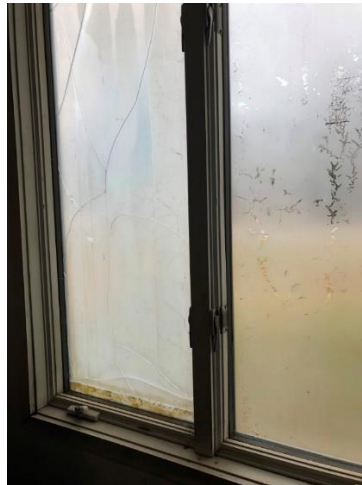
- The existing double pane windows are in very poor condition with failed seals. These can be replaced with new double pane replacements.

Figure 3: Window with Broken Seal

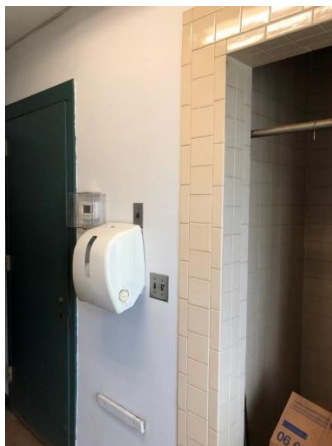
- There is significant heat loss occurring through the three garage bay doors. This is because there is only a single door entrance at the front of the building. The parking lot is located on the side of the building near the garage bay doors and the occupants use these doors to enter and exit the building. ENE Systems proposes installing a secondary entrance on the parking lot side of the building. To implement this, the existing building hallway will need to be extended through the Men's Bathroom and the water heater in the bathroom closet will be relocated.

Figure 4: Proposes Secondary Door Location in Men's Bathroom, the Green Door is the Existing Closet.

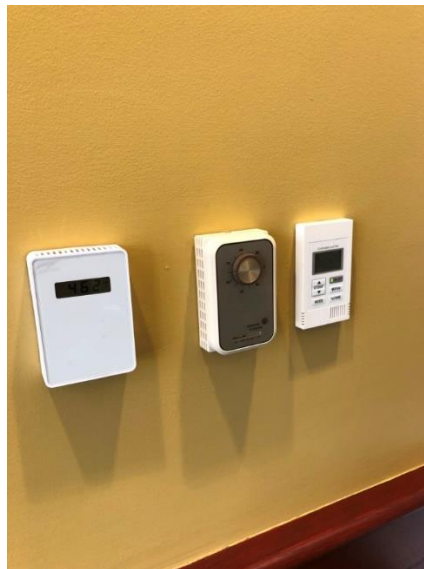
- The building currently utilizes two different sets of HVAC controls, one for the Mitsubishi Heat Pumps & ERV, and one for the Lochinvar Boilers. These two sets of controls do not communicate with one another which opens the possibility for system mismatch, simultaneous heating and cooling, excess energy consumption, and occupant discomfort. Interviews with the owner, site observations, and utility data analysis confirms that these systems are not operating in harmony. ENE Systems suggests that further investigation be performed to determine if these two separate controls systems can be merged into one. This will eliminate all afore-mentioned inefficiencies.

Figure 5: Controls Systems Present In Space; From Left to Right, CO2 Sensor for ERV, Thermostat for Boiler, Thermostat for Heat Pump.

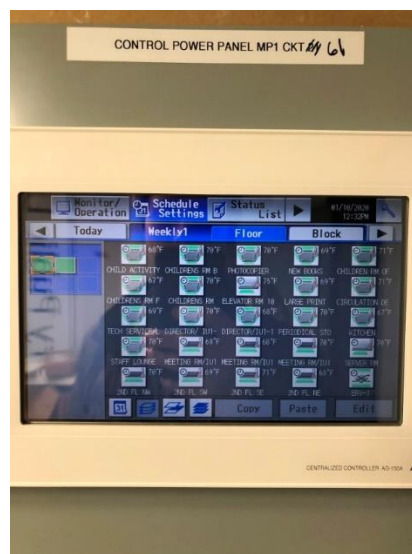
Figure 6: Mitsubishi Control System

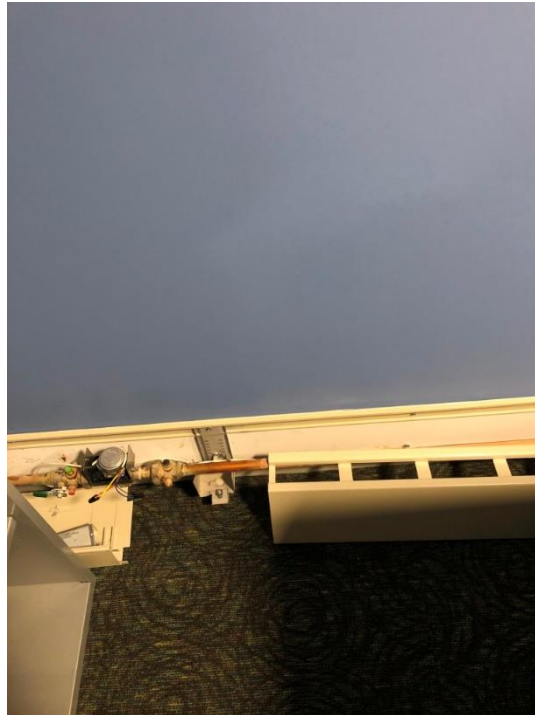
- Fins were observed missing on the Archive Room baseboard radiators. This detracts from the effectiveness of the radiator making space temperature control more difficult. ENE Systems recommends spot checking all radiators and installing fins where missing.

Figure 7: Missing Fins on Baseboard Radiator

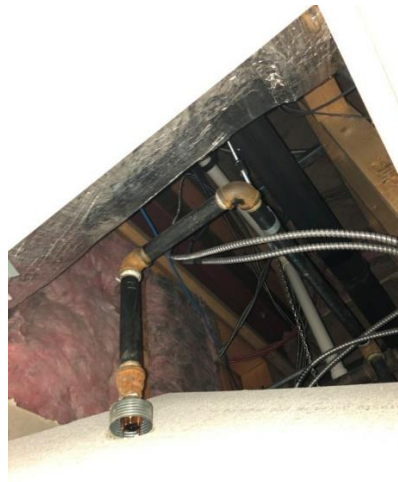
- The owner has expressed problems with sprinkler pipes freezing above the ceiling. Investigation during the audit revealed several instances of faced batt insulation improperly installed, missing, or not installed in the correct location. This is creating gaps in an air barrier that must be continuous between the outside air and interior spaces where the piping is located. One instance was observed where piping was installed in an area that is open to soffit venting. Another instance was observed where the insulation was not attached to the floor in a crawlspace, allowing air to infiltrate underneath it. In addition to freezing pipes, these gaps in the air barrier reduce the overall energy efficiency of the building. ENE Systems recommends a thorough investigation of the entire building envelope be performed to identify all gaps in the air barrier. Subsequent repair of all air gaps will be performed thereafter.

Figure 8: Sprinkler Piping Located in Space Open to Soffit Venting

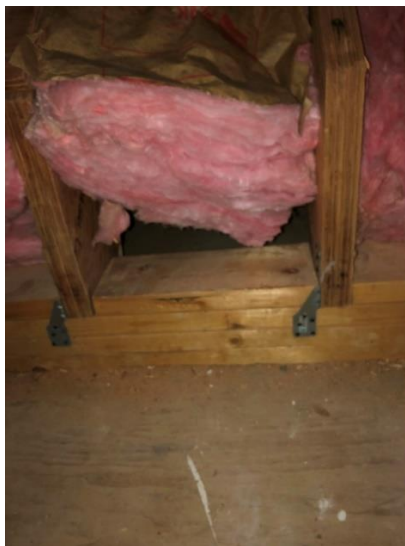
Figure 9: Insulation/Air Barrier Not Installed Continuously to Floor
