# **PHASE II SITE INVESTIGATION SUMMARY REPORT**

**29 ELM STREET  
SALISBURY, MASSACHUSETTS**

May 2008

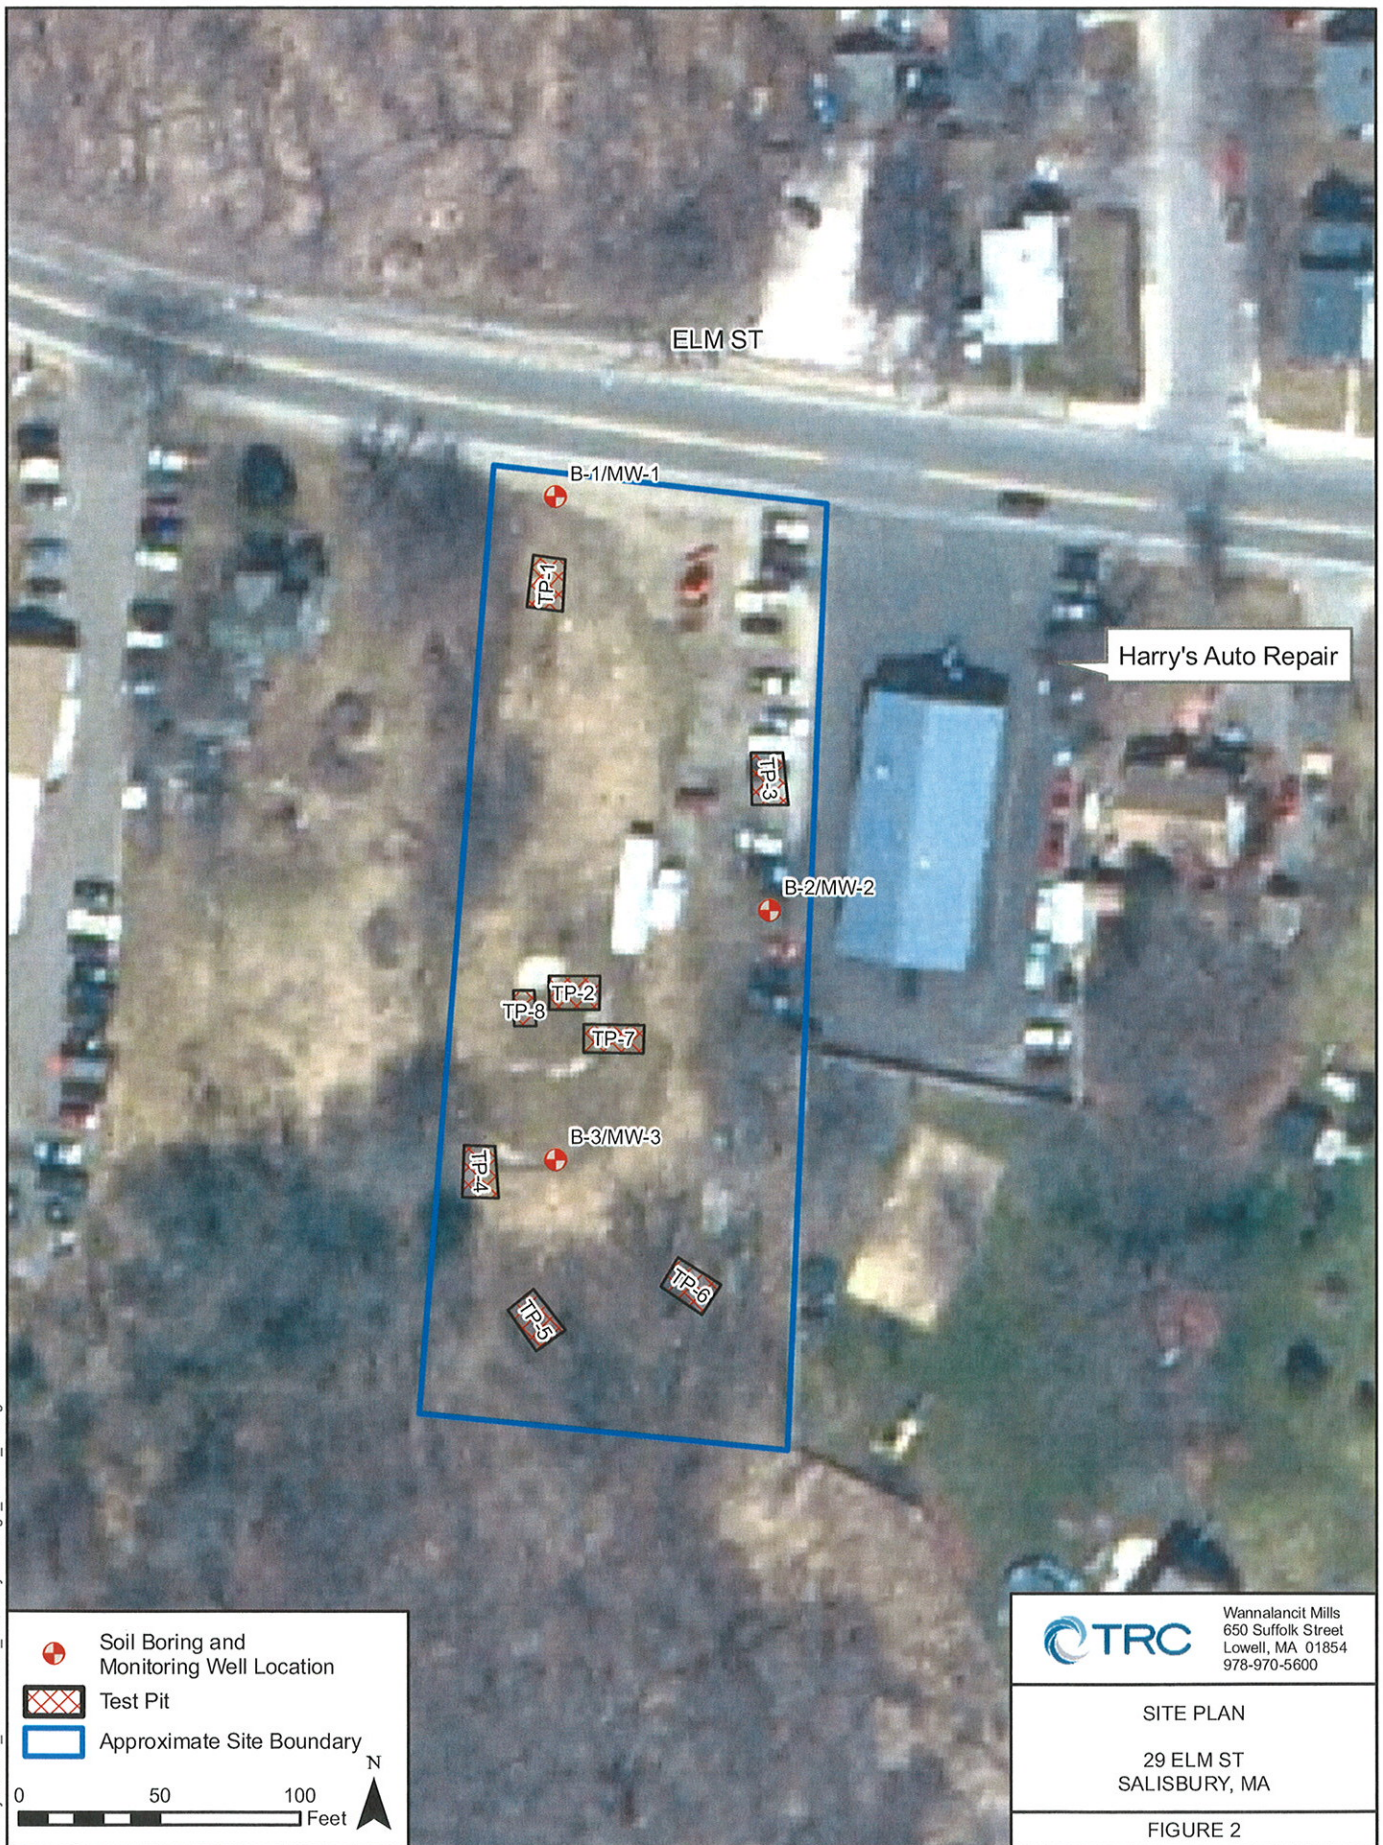
TRC's soil boring and test pit program was completed on April 18, 2008. Figure 2 depicts the locations of the soil borings and test pits completed during this project. Table 2-1 summarizes soil samples collected from the Site and submitted for laboratory analysis. Test pit and soil boring logs including well construction diagrams are contained in Appendix B. Photographs taken during test-pitting activities are located in Appendix A.

Test pits TP-5 and TP-6 were completed in the southern portion of the property (see Figure 2). Multiple PAH and metal constituents were detected at levels above the RCS-1 criteria in soil samples collected from these two locations. Soil collected from TP-6 contained the PAHs benzo(a)pyrene and phenanthrene at concentrations slightly above their respective RCS-1 criteria. Soil collected from TP-5 contained the PAHs benzo(a)pyrene and dibenzo(a,h)anthracene at concentrations just above their RCS-1 criteria. The soil samples from both TP-5 and TP-6 contained concentrations of metals above RCS-1 criteria, including antimony, arsenic, barium, cadmium, chromium, lead, nickel, and zinc. These constituents did not exceed RCS-1 criteria in other soil samples collected across the site (except TP-2, see below). Metals and PAH contamination at TP-5 and TP-6 is likely attributable to anthropogenic fill materials that were deposited in this portion of the Site.

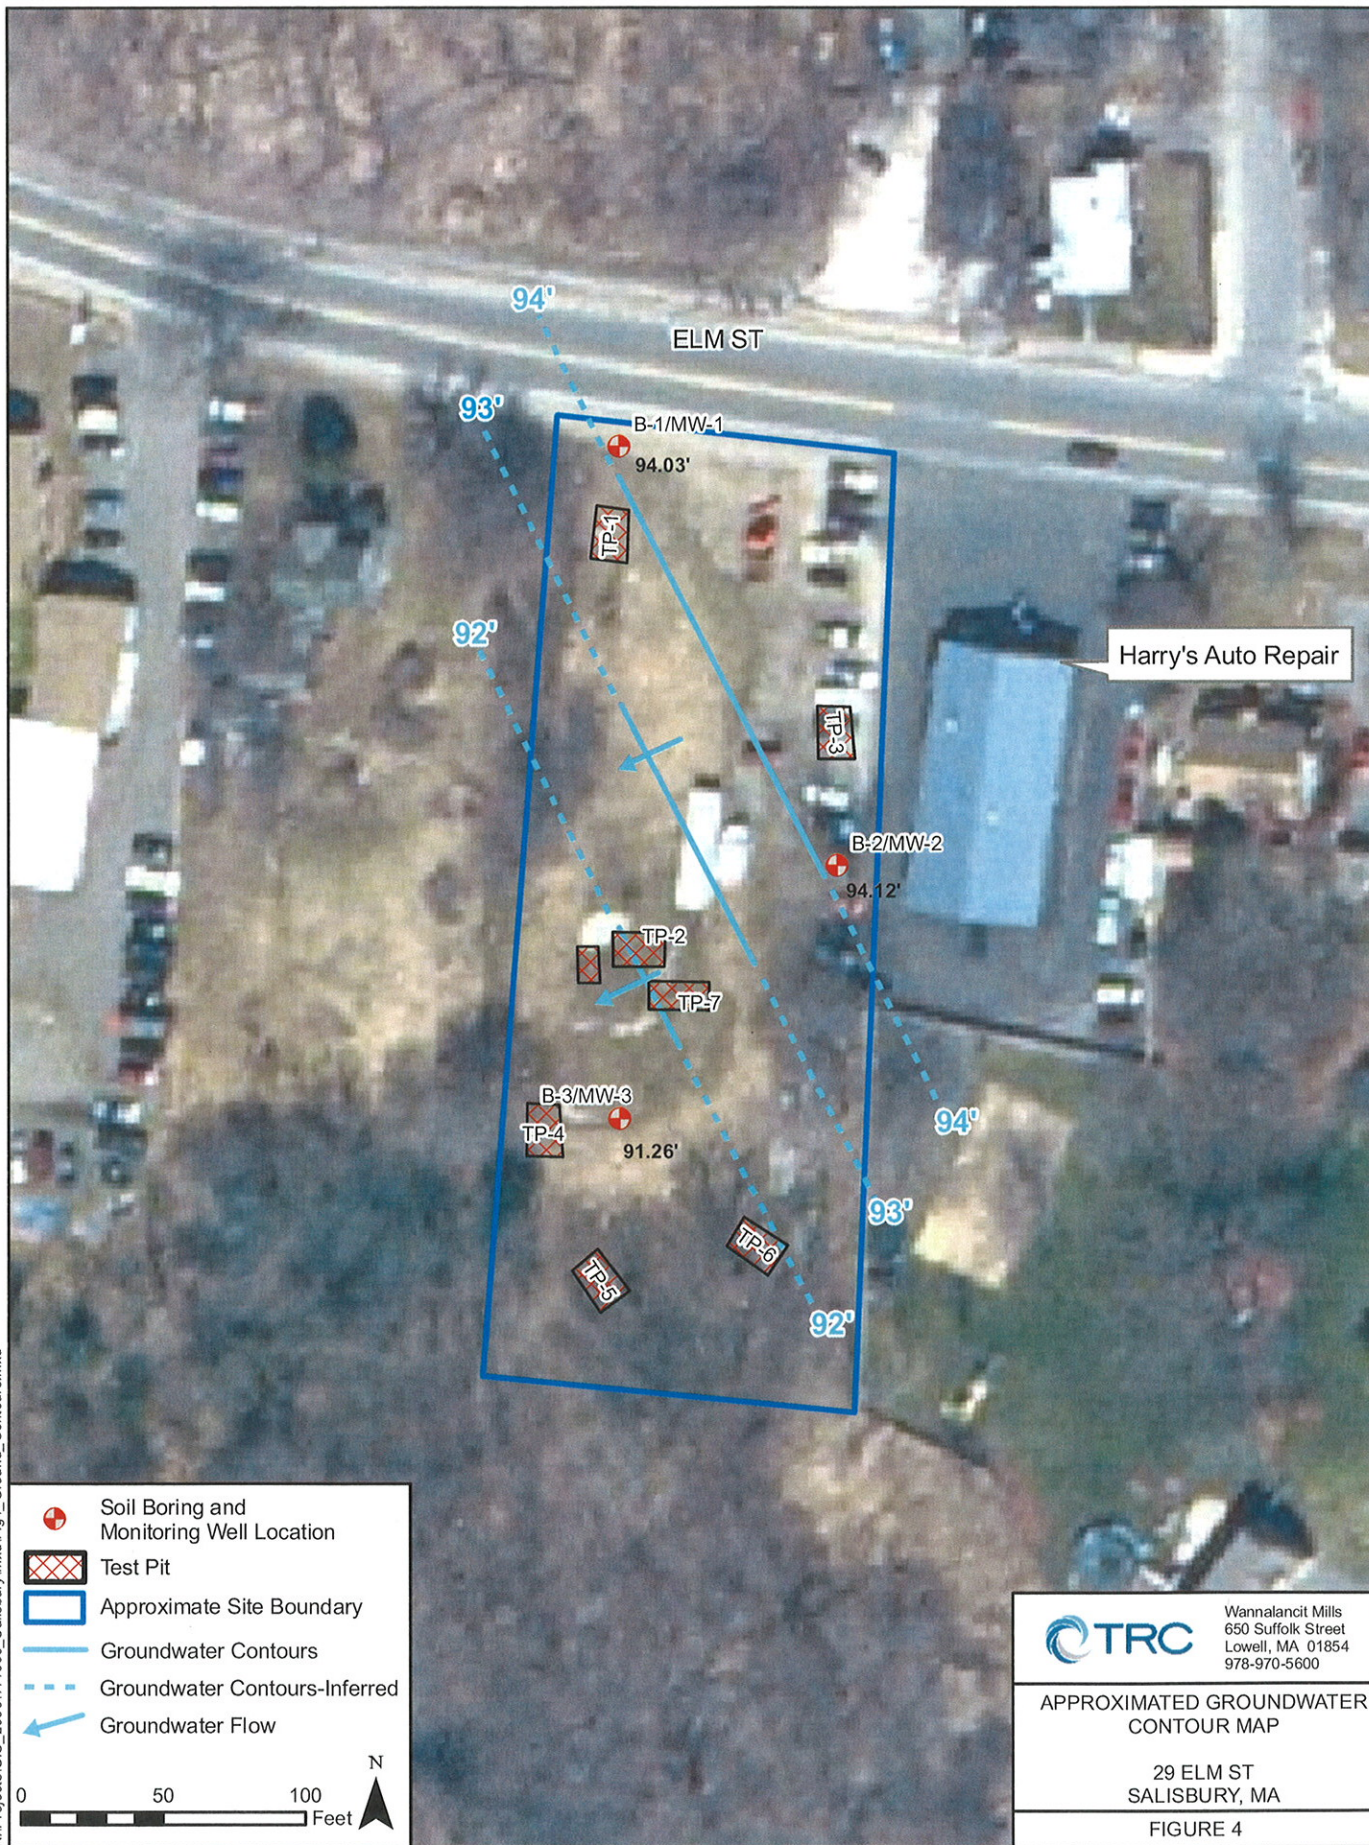
R:\Projects\GIS\_2008\114605\_Salisbury\mxd\Fig4\_Ground\_Contours.mxd

Depth to groundwater at the Site, as measured by TRC on April 25, 2008 during a groundwater elevation survey, is estimated to range from approximately 6.48 feet to approximately 8.74 feet from the top of the well risers (approximately 3.18 to 5.62 feet below ground surface [bgs]). No measurable SPH was observed during gauging activities. Based on the April 25, 2008 relative elevation survey, the groundwater table slopes to the southwest at an average gradient of approximately 0.0077 foot/foot. A Groundwater Contour plan is presented in Figure 4.

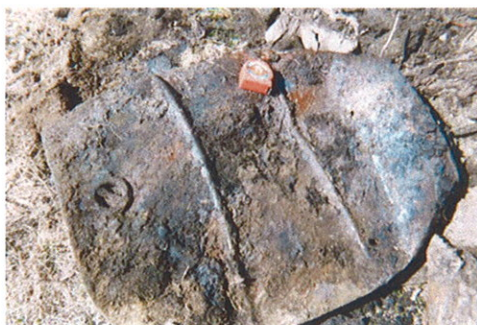
During excavation of test pit TP-2 in the concrete-lined pit of the former Site building, TRC noted elevated PID readings (>1,000 parts per million by volume [ppmv]), a strong acetone-like odor, black-stained soil and wood waste materials, and a partially crushed 55-gallon drum. Based on these observations, TRC personnel collected additional soil volume at this location for volatile organic compounds (VOCs). Additionally, two test pits (TP-7 and TP-8) were completed adjacent to the pit to assess whether observed contaminants within TP-2 had migrated outside of the pit. Samples from TP-7 and TP-8 were submitted for laboratory analysis of VOCs and SVOCs. Based on review of historical Sanborn fire insurance maps contained in TRC's 2007 Phase I report, TP-2 is believed to be associated with the elevator of the former Site building.

Crushed drum from TP-2

- Soils, waste debris, and water present in the concrete-lined pit should be removed and properly disposed to mitigate any potential human health concerns associated with potential future Site uses and to prevent potential migration of contaminants to soil and groundwater outside the pit. Additional investigation of the pit is warranted to further evaluate potential release pathways (e.g., cracks, holes, drains, pipes, outlets, etc.) from the pit to the environment.

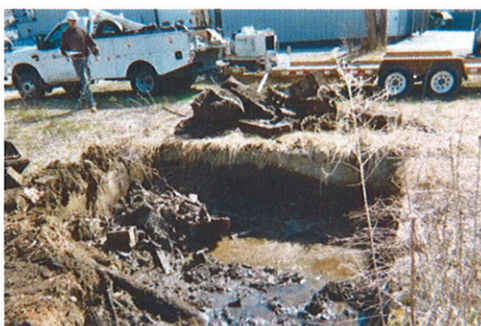
Test Pit TP-2

As described above, test pit TP-2 was completed within the concrete-lined pit believed to have been associated with an elevator in the former Site building. TRC noted PID readings in excess of 1,000 ppmv, a strong acetone-like odor, black-stained soil and wood waste materials, and a partially crushed 55-gallon drum. Soils excavated at this location exceeded the respective RCS-1 criteria for multiple VOC, VPH, EPH, and SVOC constituents, as well as cadmium, chromium, and lead. TRC did not observe cracks or voids in the concrete sides of the pit. Standing water in the pit precluded observation of the condition of the concrete on the bottom of the pit. Based on the continuous level of water standing in the pit on April 18, the concrete pit does not have large cracks or voids. Test pits TP-7 and TP-8 were completed on the south and west sides of the concrete-lined pit, respectively. Soil samples collected from TP-7 and TP-8 were analyzed for VOCs and SVOCs. Sample results indicated no detectable compounds. Based on the soil sample results from TP-7 and TP-8 and observations of the condition of the concrete pit, the contamination detected in soil excavated from TP-2 does not represent Site soil conditions (i.e., contaminated soils and debris in this area are contained in the concrete-lined pit and not in subsurface soil).

While excavating TP-2, the concrete-lined former elevator pit was found to contain approximately one foot of standing water, observed to be brown and turbid with traces of a sheen. The static level of water in TP-2 was approximately three feet below grade. In test pits excavated immediately adjacent to the concrete pit (e.g., TP-7 and TP-8) static water levels were approximately six to seven feet below grade. This indicates that the water in the pit is not hydraulically connected to groundwater in the immediate vicinity. Further, groundwater samples collected from the three monitoring wells installed on Site did not contain detectable levels of the contaminants detected in the water sample collected from TP-2. These results indicate that water from the concrete pit is not representative of groundwater conditions at the Site. TRC has compared analytical data for water from the pit to RCGW-2 criteria as a general guide to the significance of the detected concentrations. Acetone (5,220 µg/L), methyl isobutyl ketone (5,520 µg/L), toluene (2,590 µg/L), and m and p-xylenes (247 µg/L) were detected in water sampled from TP-2 at levels below RCGW-2 criteria.

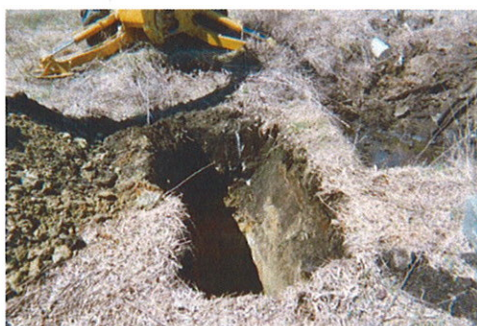
Soil samples taken from TP-2 exceed the RCS-1 criteria for a number of VOC, SVOC, EPH, VPH, and metals constituents. Based on non-detect sample results from test pits TP-7 and TP-8 taken downgradient from and adjacent to TP-2, as well as the observed intact nature of the concrete pit, the contamination found at TP-2 is limited to the concrete-lined pit. Therefore the material excavated from TP-2 is not representative of Site soil conditions and does not represent a reporting condition under the MCP. Although soil excavated from TP-2 is not indicative of Site soil conditions, the soil and other pit contents will still require appropriate characterization and management to prevent potential future exposures and to facilitate future site development.

Test Pit TP-7 adjacent to concrete lined pit.

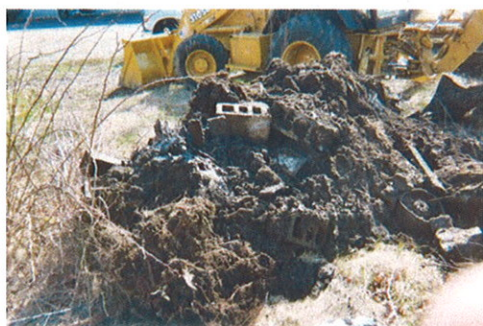
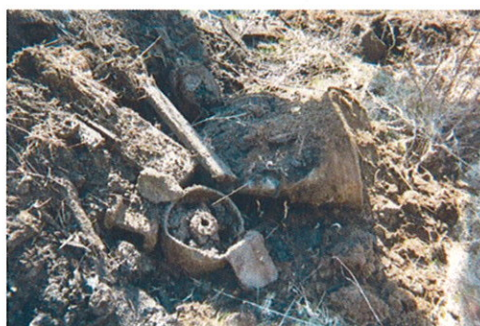
Material excavated from TP-2.

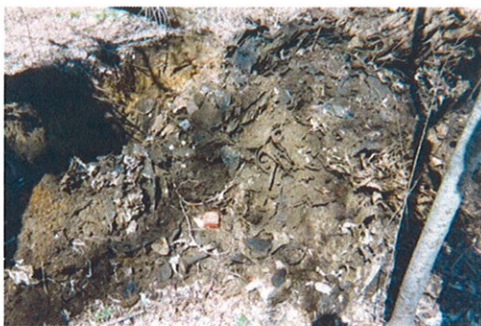
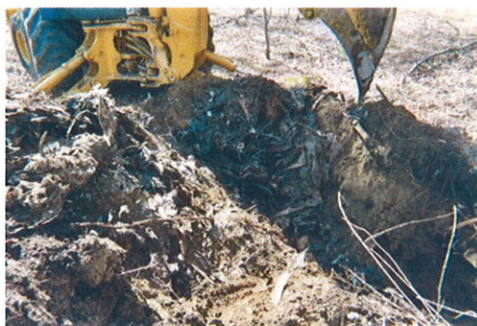
Shoe leather excavated from TP-5.
