RE: Salisbury Public Library Grant Application
Geotechnical Report/Soil Evaluation Information

FORM 11 - SOIL EVALUATOR FORM

Job. #11002

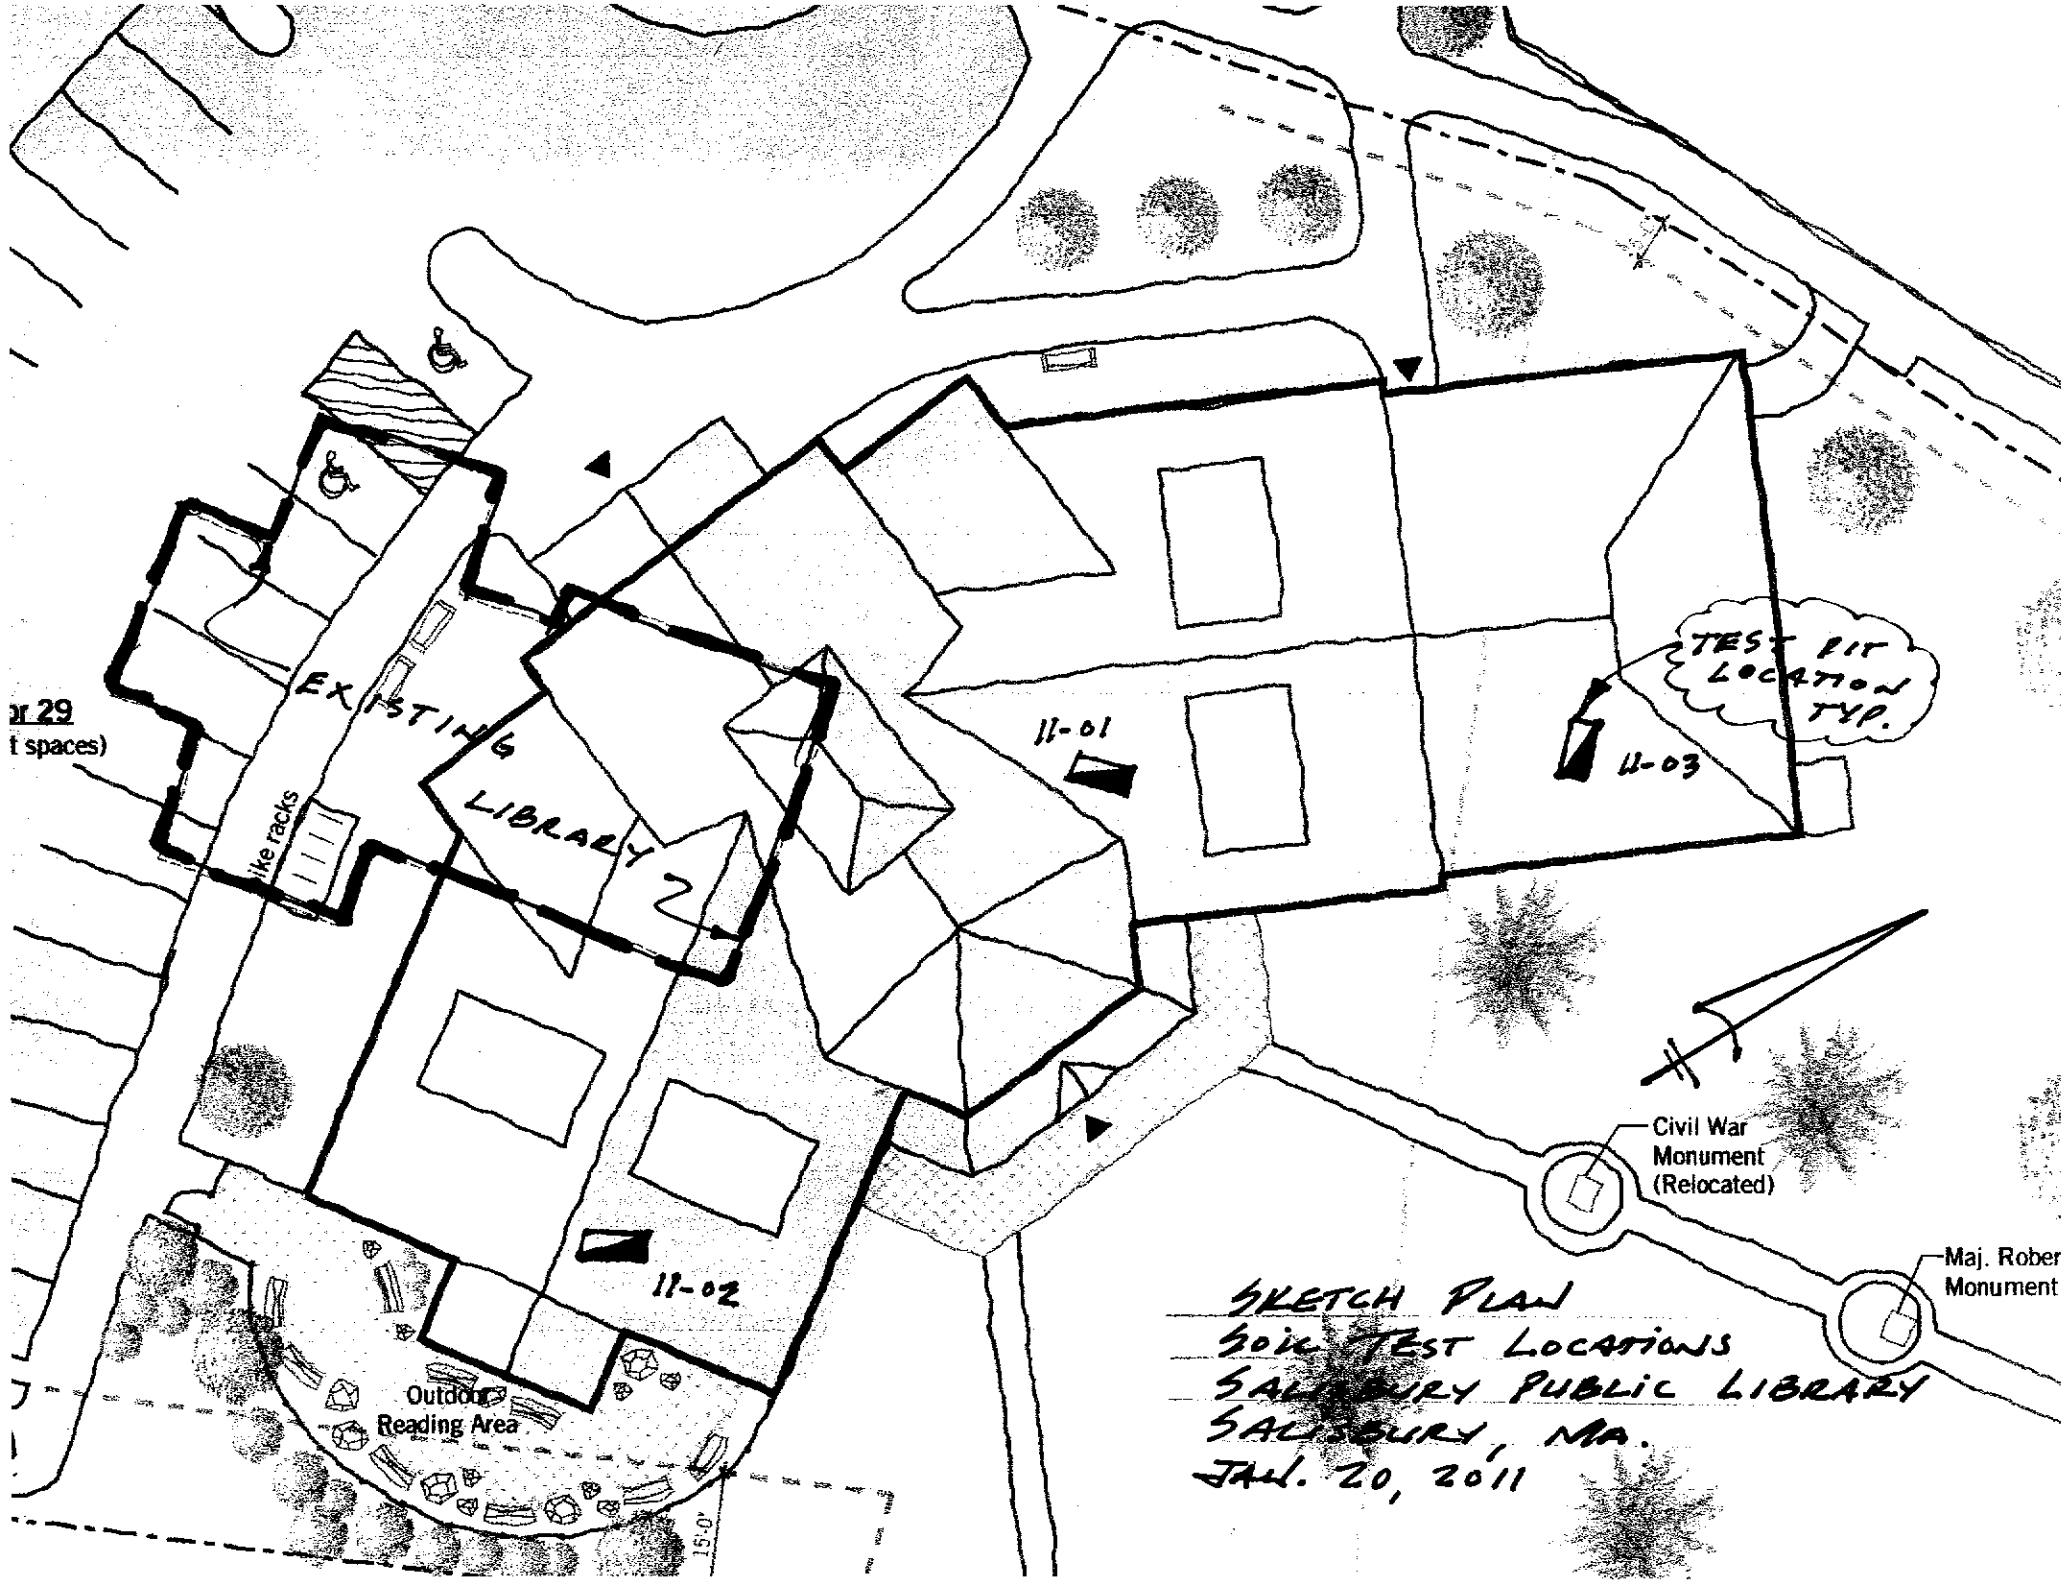
In summary, areas to the north of the existing library appear to have been filled wetlands at some point in time as there is a gravel fill material, varying in depth from 2' -3', placed over an organic soil with hydric soils beneath. The area to the east of the existing library also appears to be filled land, although the soil beneath the fill does not appear to be a wetland soil. There was no ledge encountered at any of the test pit locations to the depths indicated in the test pit logs. Depths to estimated seasonal high water table varied from 33" to 50".

Due to the existence of the organic soil layer in areas where the library is proposed to be constructed, special consideration may be required for the building's foundation design in order to support the structure on these soils, unless these soils are removed and replaced with clean structural fill to support the building. This could impact the cost of developing the project site.

or 29
t spaces)
ike racks
EXISTING
LIBRARY
11-01
11-02
11-03
TEST PIT
LOCATION
TYP.
Outdoor
Reading Area
15'-0"
Civil War
Monument
(Relocated)
Maj. Rober
Monument
SKETCH PLAN
SOIL TEST LOCATIONS
SALISBURY PUBLIC LIBRARY
SALISBURY, MA.
JAN. 20, 2011
